**Characterization of surface  
alterations on surgical  
instruments caused by  
silicates and titanium oxides**

Wolfgang Fuchs<sup>1</sup>, Elisabeth Schneider – 1 – AKI - Working Group Instrument Reprocessing; Aesculap AG, Tuttlingen  
Dr. Matthias Tschoerner<sup>2</sup> – 1 – AKI - Working Group Instrument Reprocessing; Chemische Fabrik Dr. Welgert GmbH und Co. KG, Hamburg

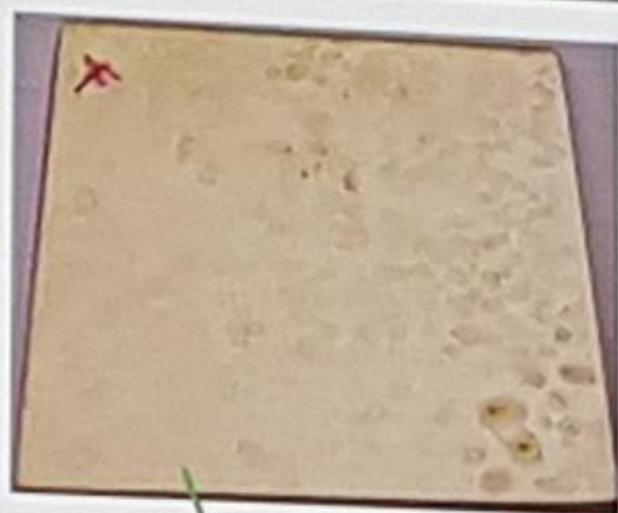
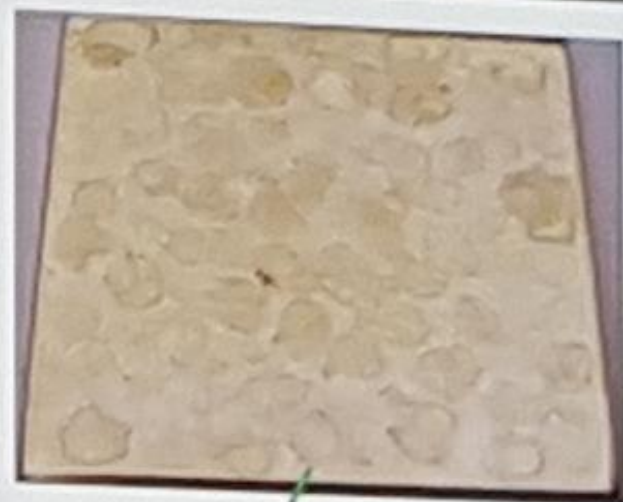
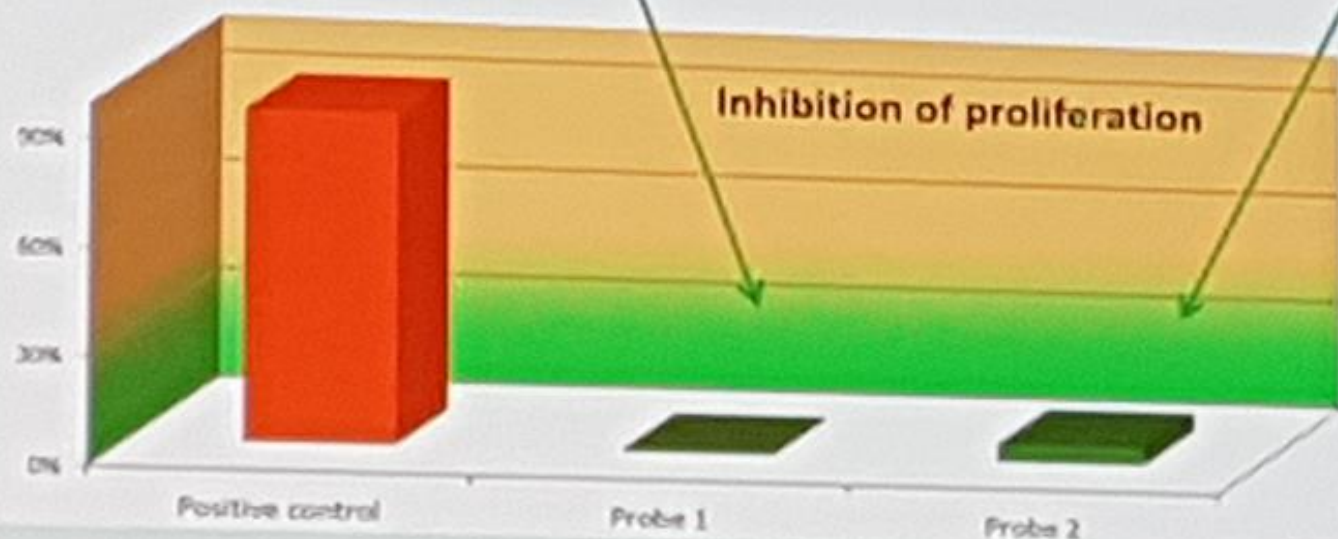
## Cytotoxicity

Strong spots due to silicate deposits during sterilization in the autoclave.

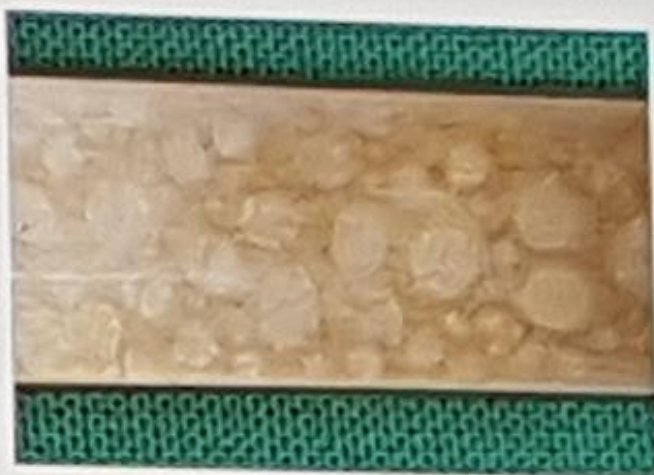
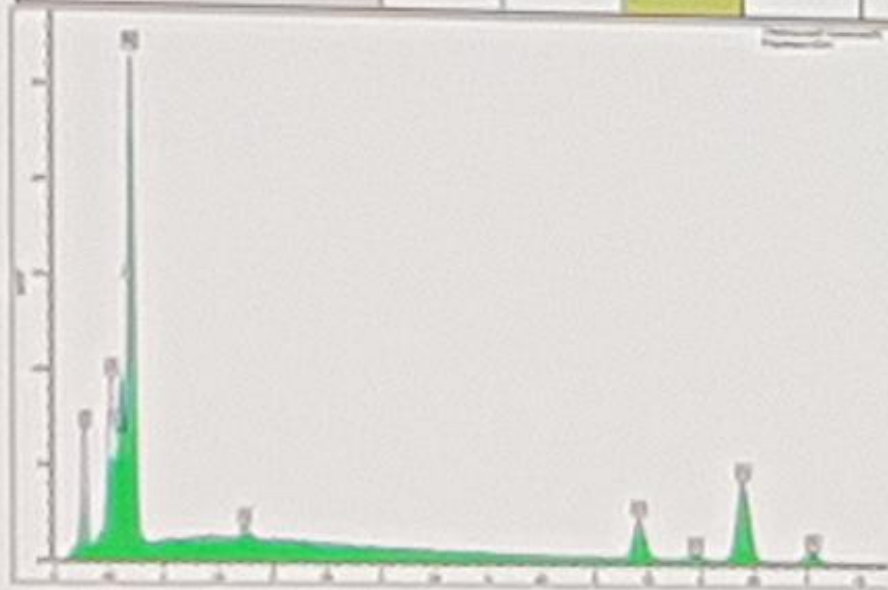
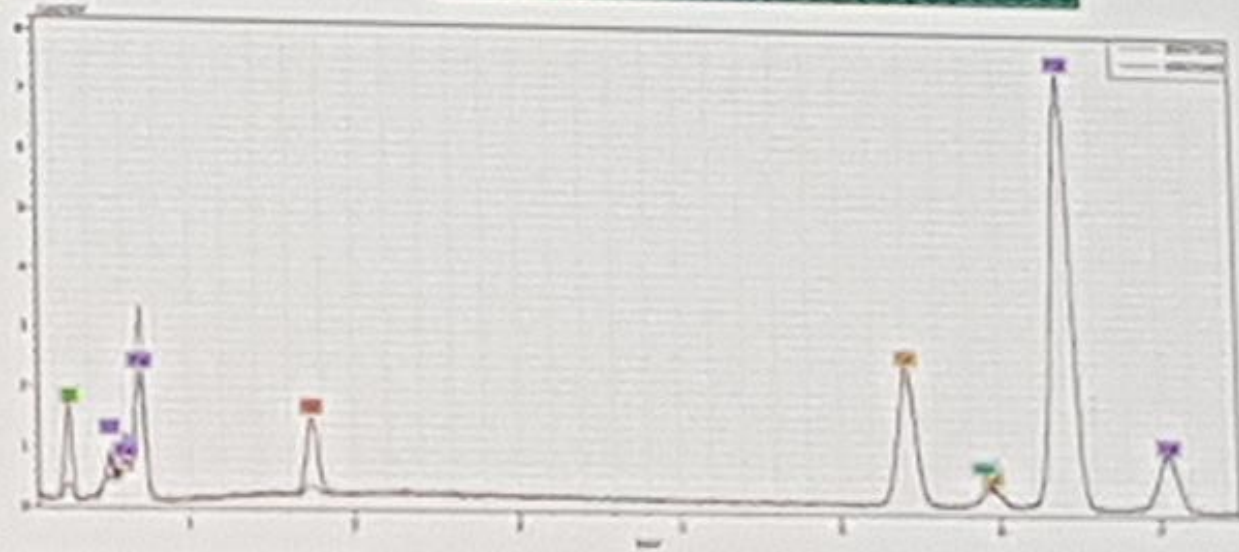
## Osteotom, EDX

Element analysis	C	O	Si	Cr	Fe
Instrument material	8,23	2,91	0,41	13,7	73,2
Discolored Surface	4,49	0,86	0,37	14,4	79,9

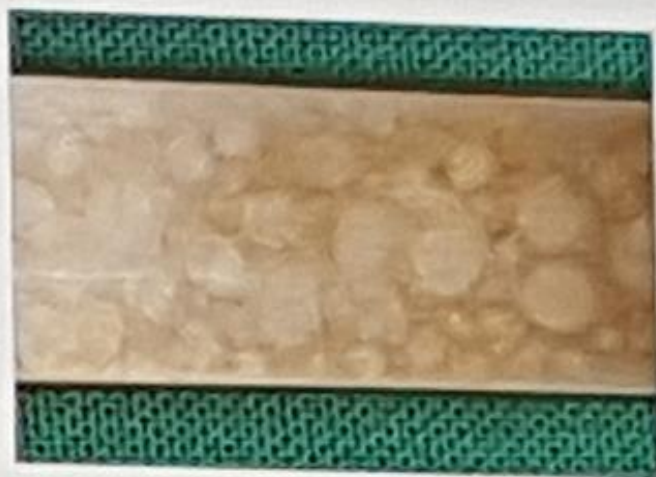
## Osteotom, XPS

Element analysis	C	O	Si	Ti	Cr	Fe
Discolored Surface	79	15,4	1,4	-	0,4	0,4
Discolored Surface, 4 min sputtered	56	23,2	1,5	-	3,9	6,6

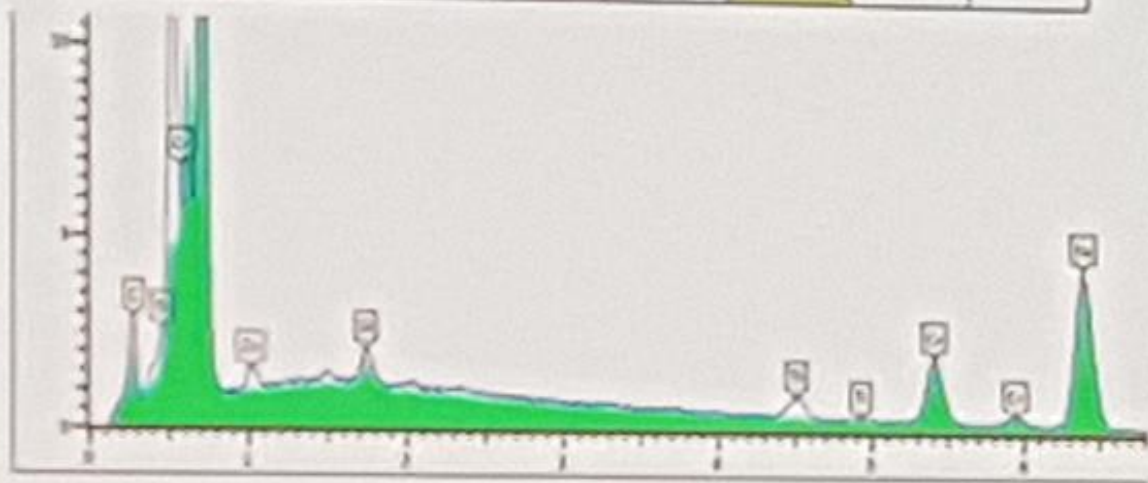
## Wound hook blue, EDX

Element analysis	C	O	Si	Ti	Cr	Fe
Instrument material	2,02		0,58	0,37	13,7	83,3
Discolored Surface	0,9	1,59	0,22	1,24	8,35	86,0

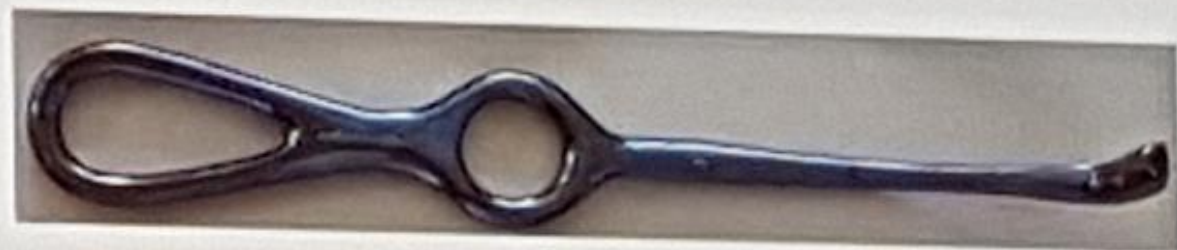
Wound hook blue, XPS

Element analysis	C	O	Si	Ti	Cr	Fe
Discolored Surface	76	17,3	0,8	1,5	0,3	0,7
Discolored Surface, 4 min sputtered	17	46,9	-	13,8	1,9	18,8

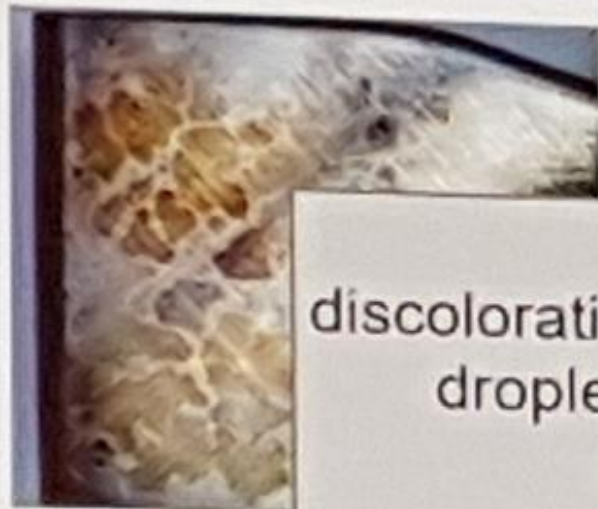
discoloration like condensation droplets on all surface structures

Silica deposits (ca. 10 nm)

silicic acid deposits caused by contaminated sterilization steam

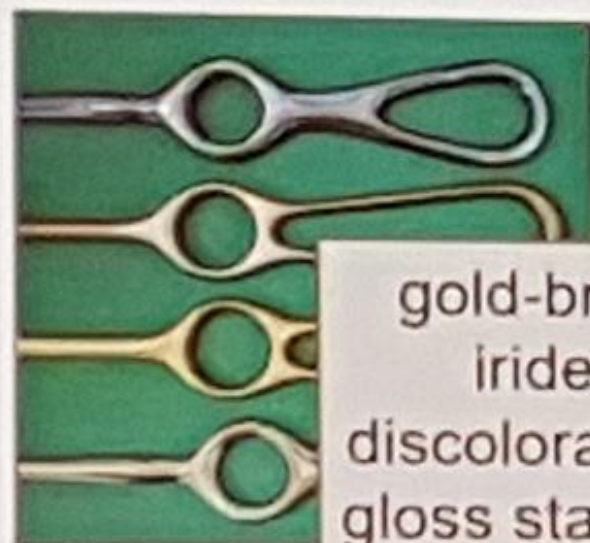
gold-brown to blue-violet, iridescent, uniformly discoloration of smooth high-gloss stainless steel surfaces

Titanium oxide layers (ca. 10 nm)

caused by traces of titanium minerals in silicate-containing cleaners

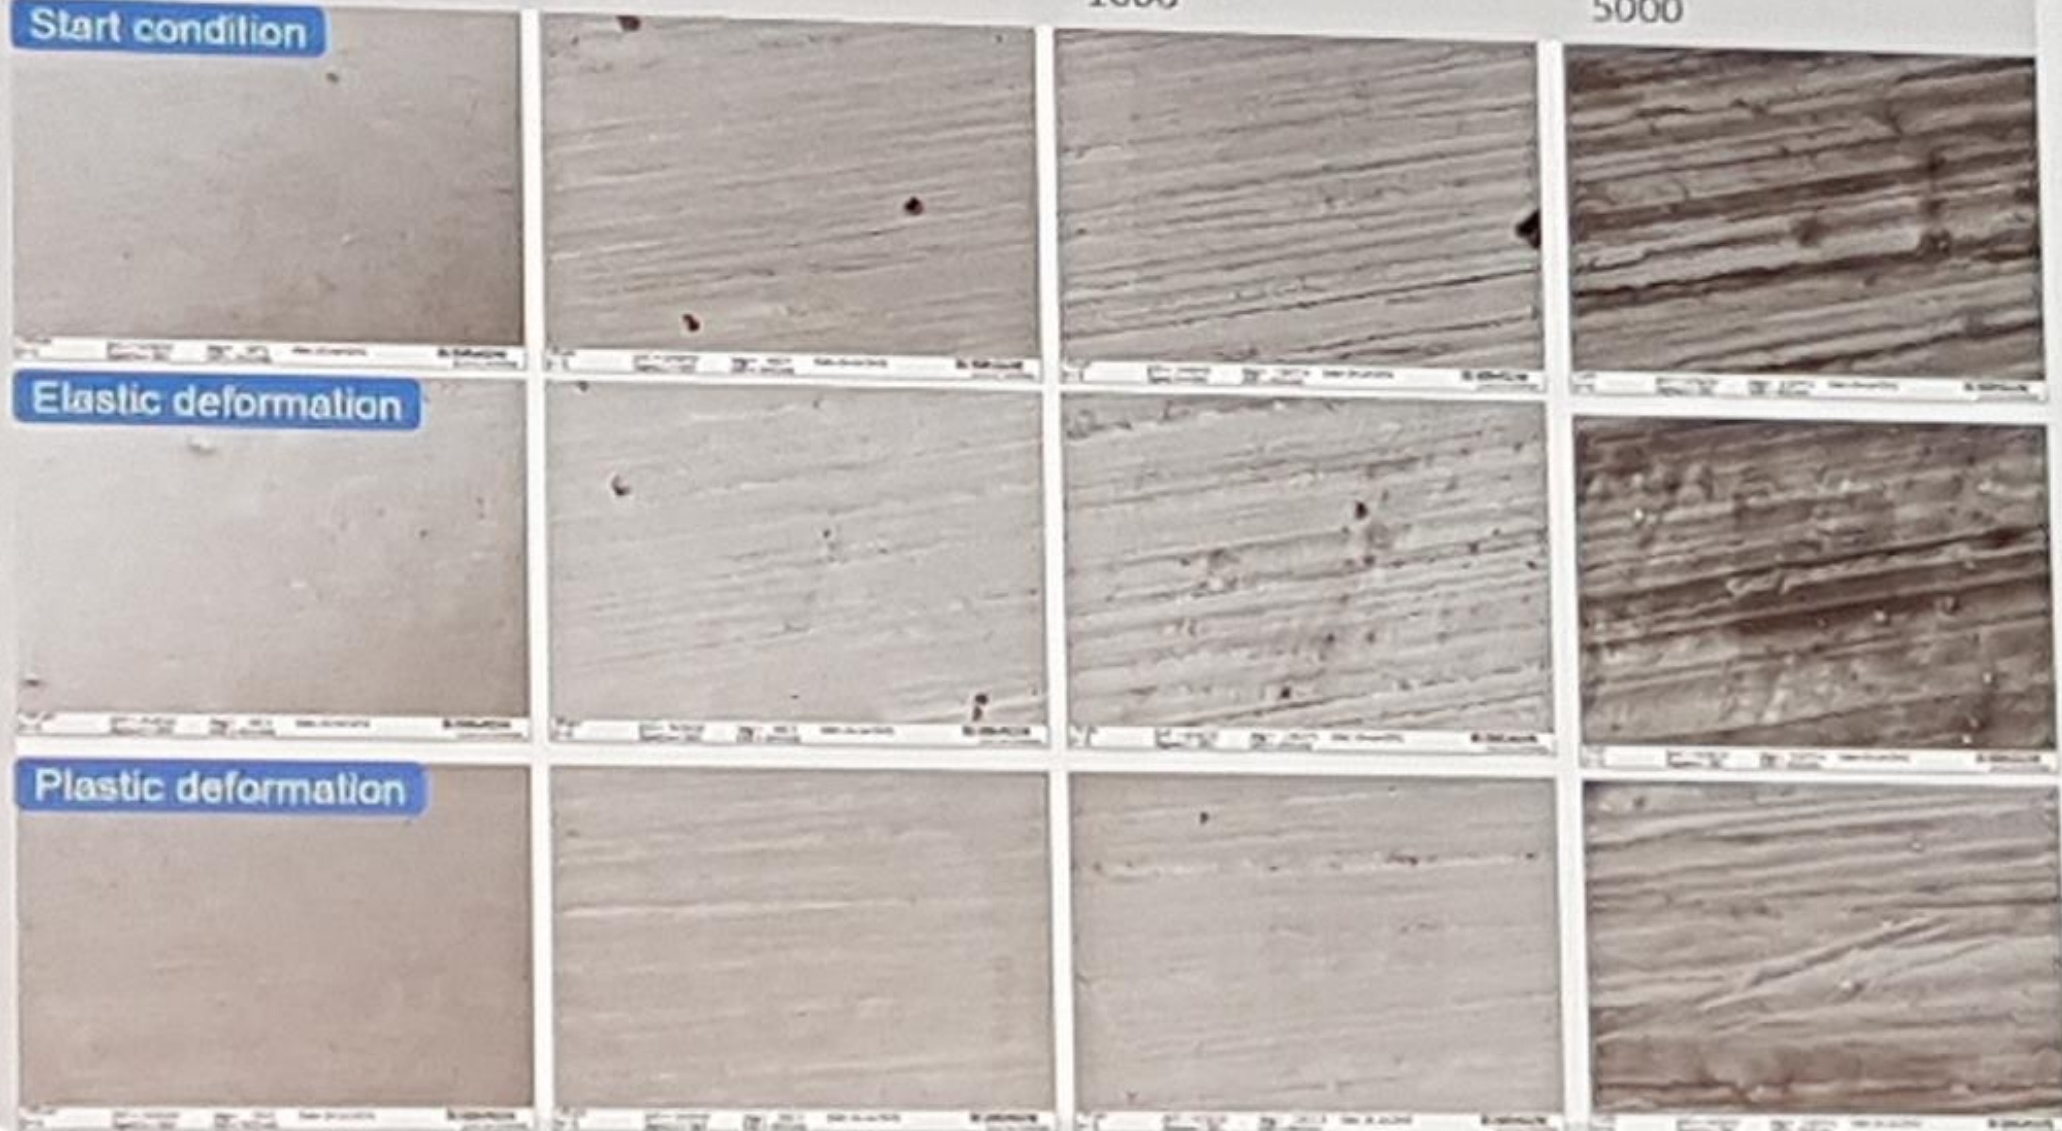
Osteotom:

- The discolorations are caused by a few nm thin titanium oxide layers and silicate layers.
- After mechanical stressing, no changes in the surface structure were observed for all characterized linings. No disruption or detachment were observed with SEM.
- Due to mechanical stress, no particles of SEM detectable size were separated from the test instruments.
- The investigated deposits show no cytotoxic properties.
