## Discoloration and Surface Changes

Dr. Ing. Gerhard Kirmse, Dr. Lena Höcker, M.Sc. Philipp Steinmetz, Silke Winandi

Aesculap AG  
Technical Competence Center

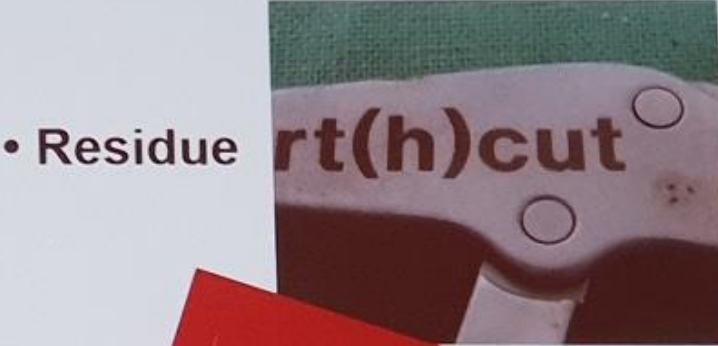
• Corrosions

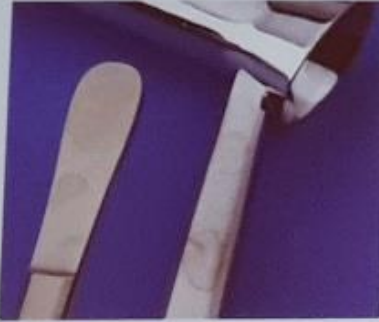
### Lime Scale

- Hardness of water
- Steam quality
- Can be removed by demineralized water or acids

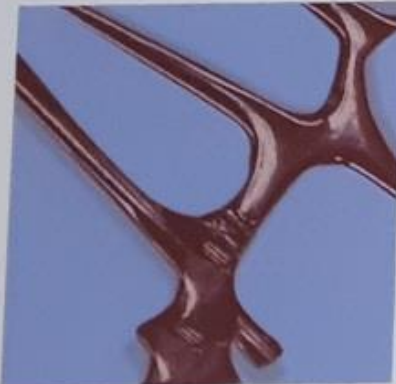
### Silicate

- Variety of appearance
- Water quality, Steam quality
- “Silicate breakthrough”
- (Cleaner carry over)

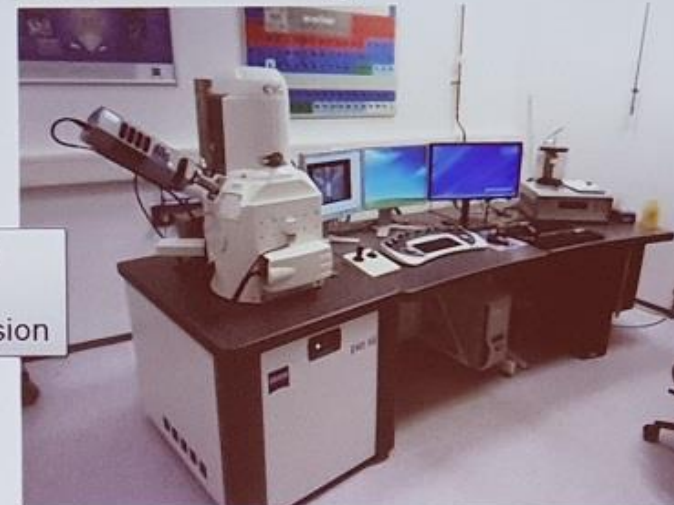
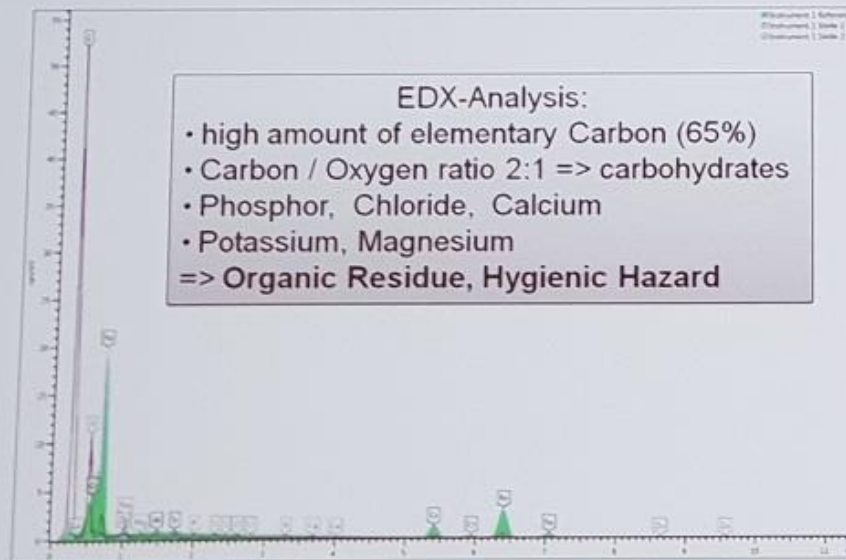
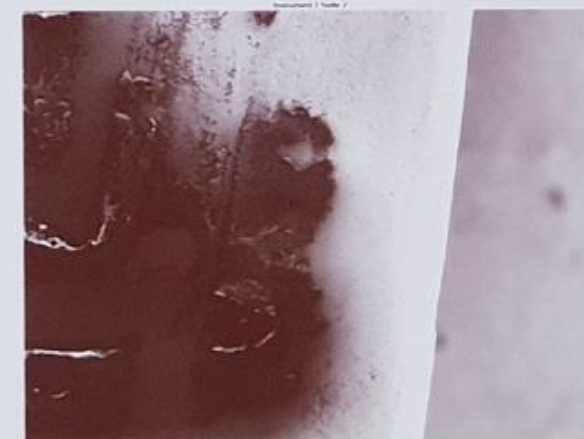
Instruments picked from working Sets  
primary Assessment: Corrosion

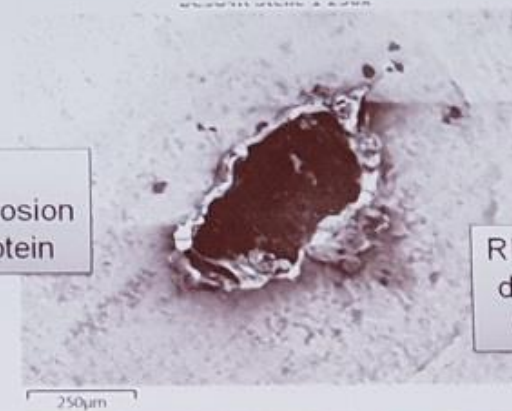
Example:  
Old Pitting Corrosion  
here 63µg Protein

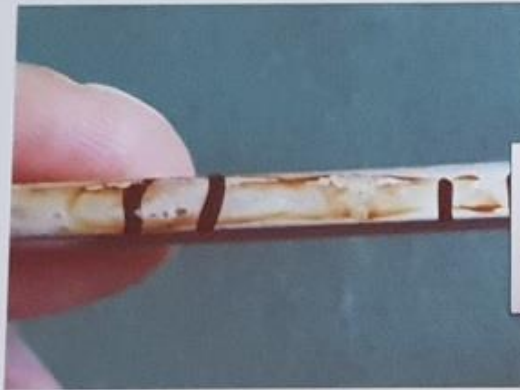
REM-Picture:  
deep Pitting  
Corrosion

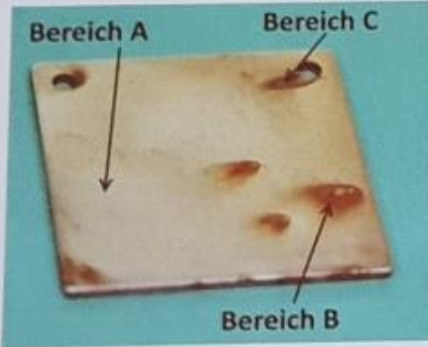
„Laboratory –  
created  
Pitting Corrosion“

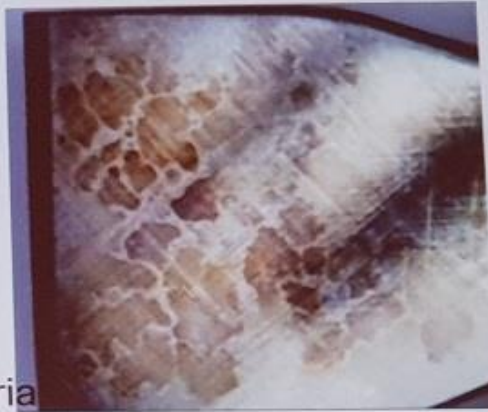
Depends on Material

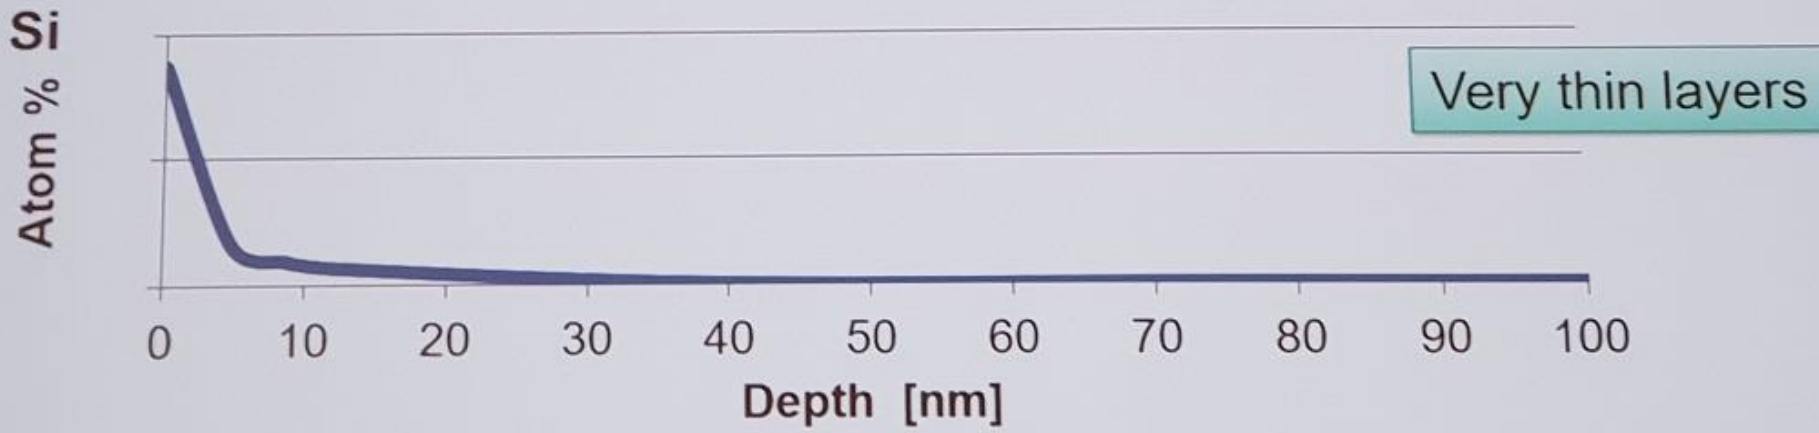
- Layer Thickness 1 – 10 nm
- Si  $E_b$  102,8 eV  $\rightarrow$  chemical Condition  $SiO_2$

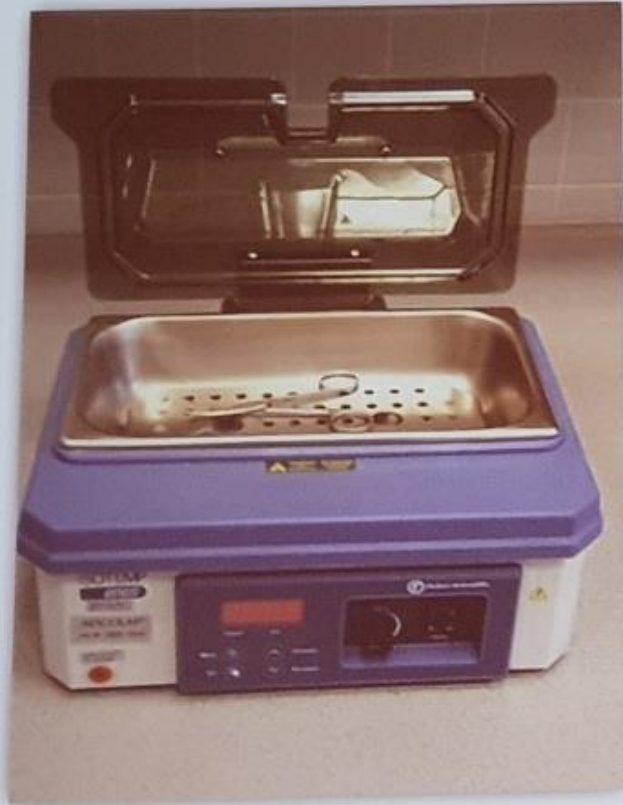
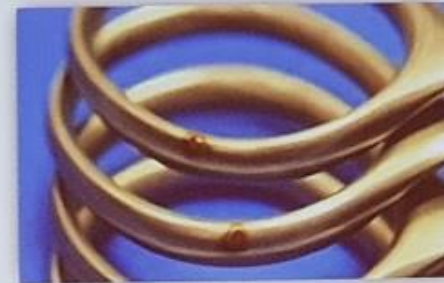
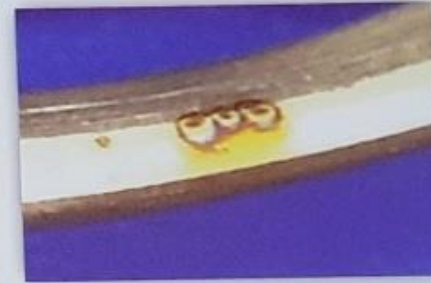
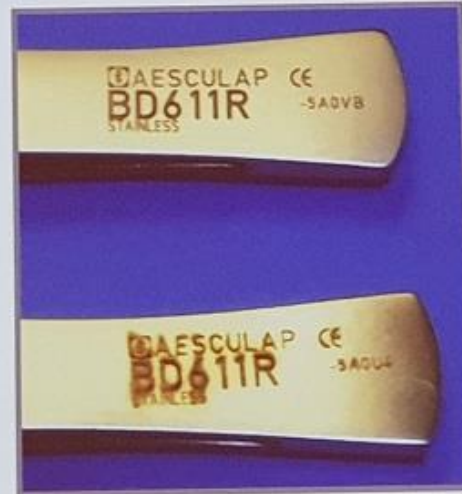
## Boiling Test DIN EN ISO 13402 - Test Method for Corrosion resistance

### Execution

- Clean
- Boil 30 min in Demineralized Water (EN 285)
- Cool 60 min in Water
- Dry 120 min (Air)
- Inspection

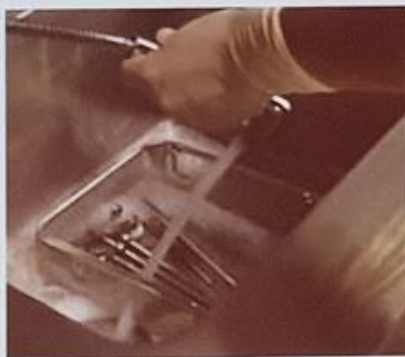
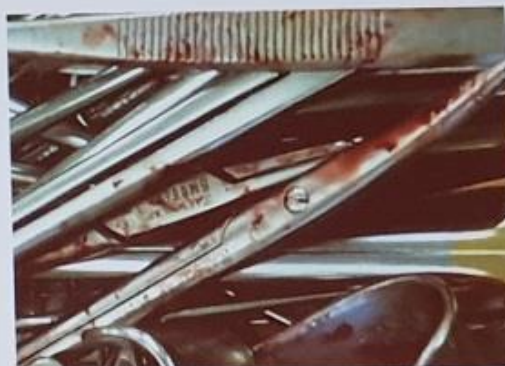
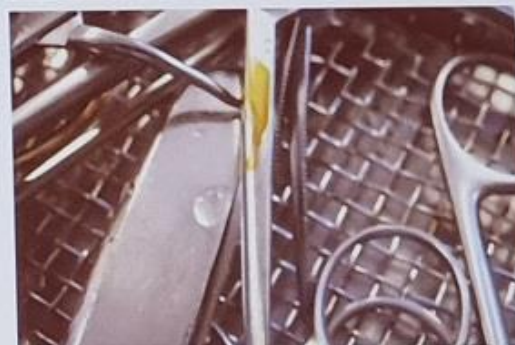
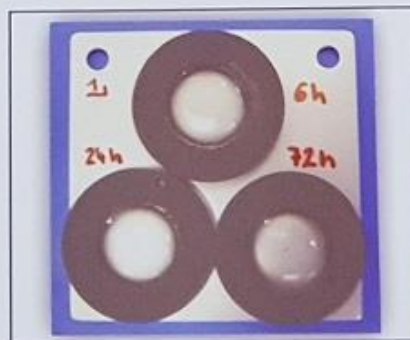
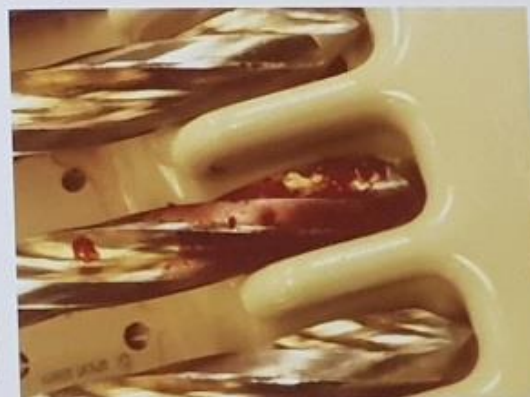
# Sodium Chloride

NaCl 0,9%, 1h

NaCl 0,9%, 2h

NaCl 0,9%, 6h

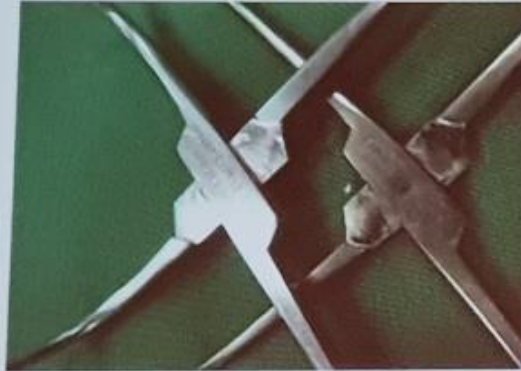
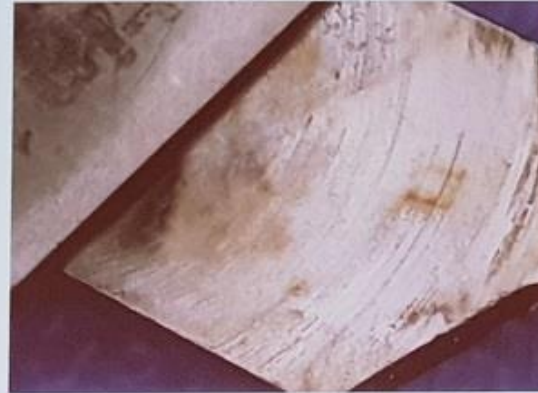
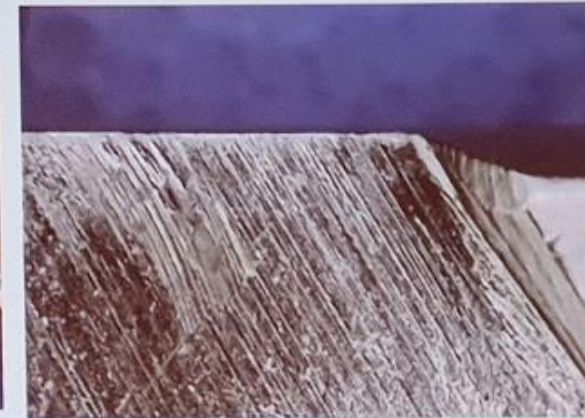
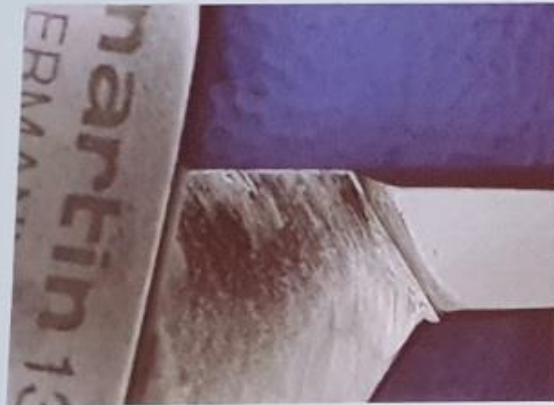
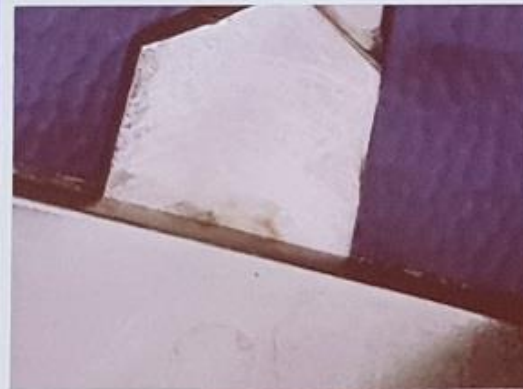
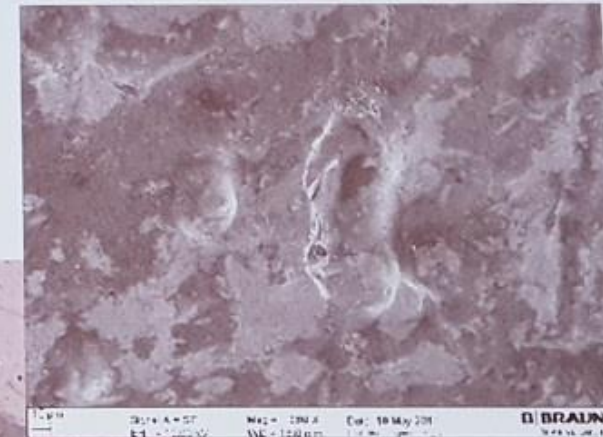
# Results

- Corrosion holes/ Scratches remain
- Limited access to crevices and cavities

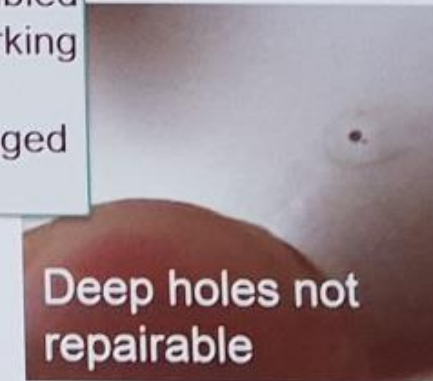
Grind down to undamaged material

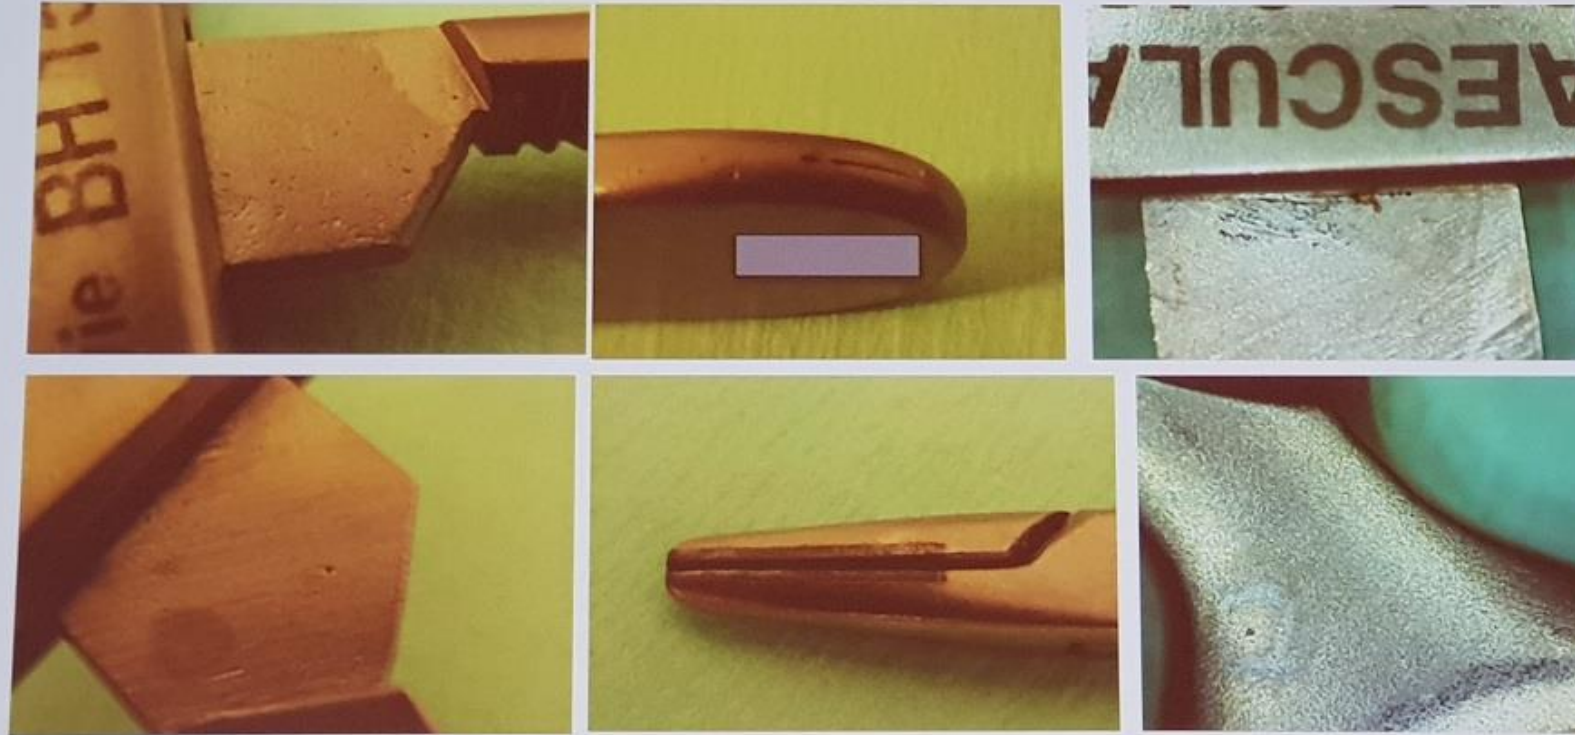
# „Low level“-Repair – Surface Repair of corrosion

- Surface repair does not work on deep corrosion
- Surface / solder / etc remain damaged
  - Corrosions re-occur quickly (here: 2 months)

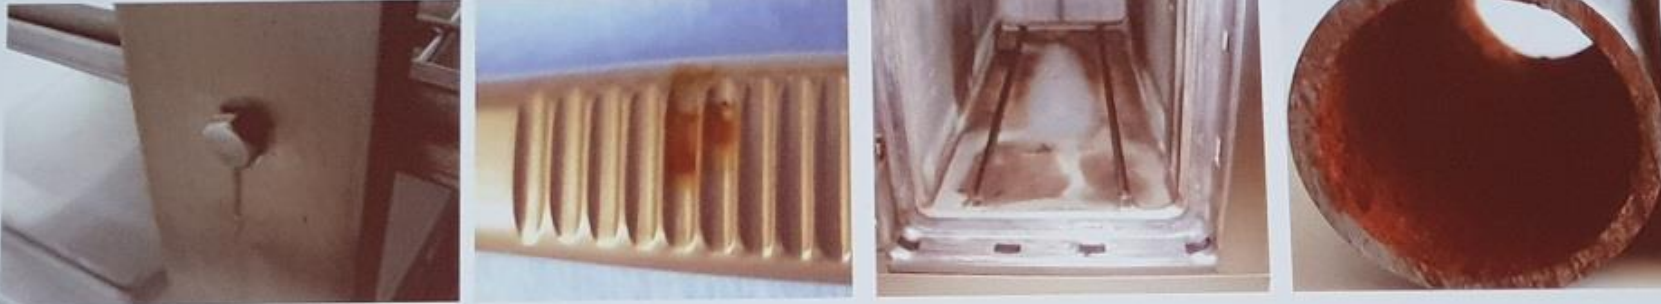
Corrosion in one area

Will travel over time
